# Manhole Inspection Summary

Manhole # S09WW\_004MH

Insp Date: **1/27/09 10:46 AM**

**Location** Address: **3500 EDGEWOOD RD**

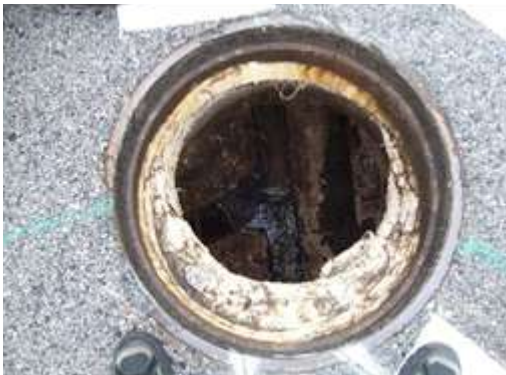
Defect 2

Offset: **4** (in.)

OFFSET FRAME

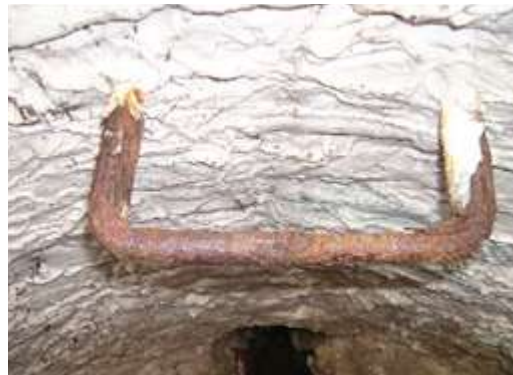
Defect 1

Count: **1** Missing: **0** ☒ **Corroded**

CORRODED RUNG

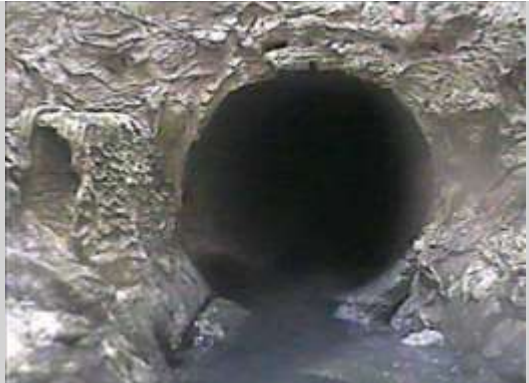
9 O'Clock Inflow

Infiltration: **None** Pipe Seal Cond: **Broken**
